FOREIGN OBJECT DAMAGE: CAUSES AND PREVENTION

1 January 1970 through 31 December 1976

by
MSG Jerry E. Mills

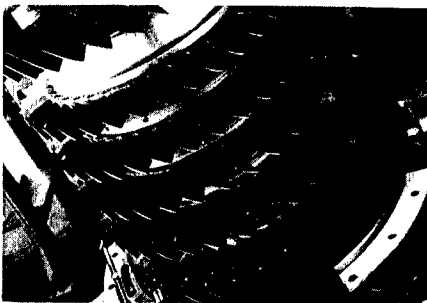
- UH-1C forced landing - Engine failed during flight. Caused by ingestion of Dzus fastener into compressor section. (figure 1)

FIGURE 1.—Damage to compressor blades caused by ingestion of Dzus fastener.

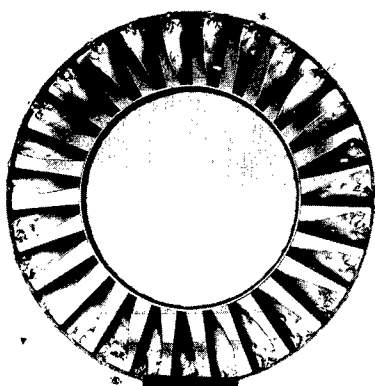
- UH-1H incident, \$438 damage - Aircraft was in stabilized hover during test flight when several loud bangs were heard and heavy feedback in controls and severe vibrations were felt. Hovering autorotation was executed, resulting in hard landing. Investigation revealed severe FOD. Imprints of the phillips head screw and threads and general imprint of Dzus fasteners left little doubt as to the type of foreign objects. (figures 2a and 2b)

FIGURE 2a.—Damage to inlet guide vanes caused by Dzus fastener.

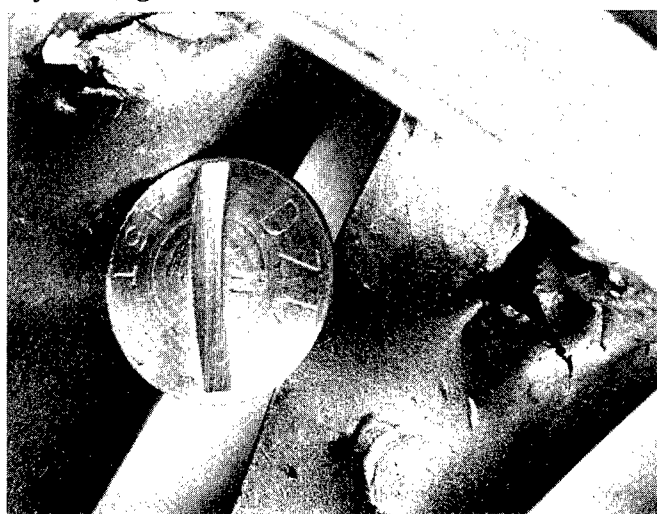
FIGURE 2b.—Closeup of damage.

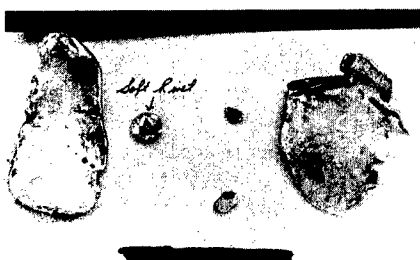
FIGURE 3.—Compressor blades and rivet removed from engine.

- AH-1G total loss, 2 injuries and \$471,630 damage - During final approach, high sink rate was encountered. There was no response to applied corrective action. Aircraft impacted twice and then became inverted in water. Investigation revealed engine malfunctioned due to FOD. The object could not be definitely identified, but it resembled a soft rivet. (figure 3)

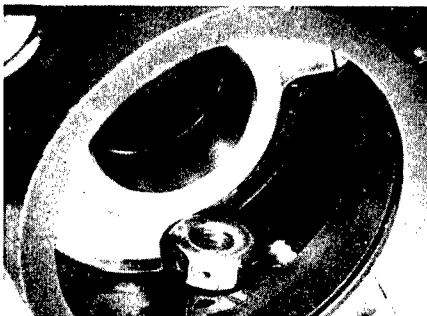
FIGURE 5.—Nut found in oil inlet cavity.

- UH-1H precautionary landing - Master caution light came on and engine oil pressure dropped to zero. Nut was lodged in oil inlet cavity. (figure 5)

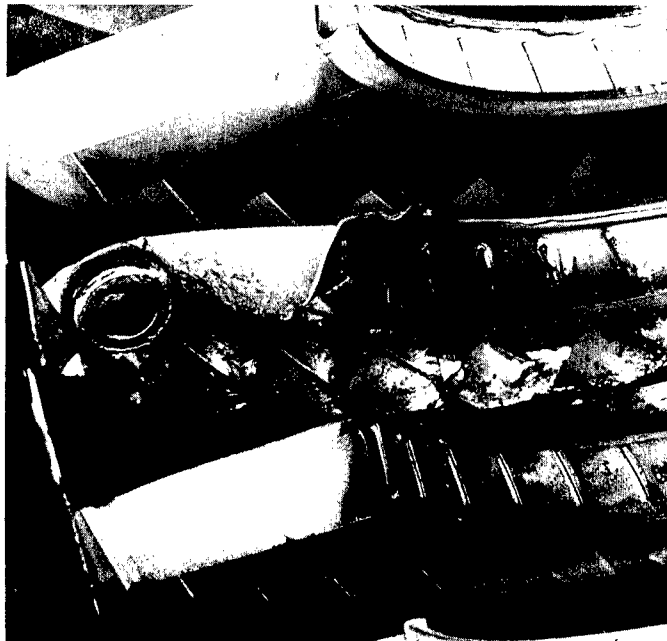
FIGURE 6a.—Washer ingested in stator vanes . . .

- CH-47A precautionary landing - Loud bang was heard and vibrations felt. Failed engine was secured and landing was made. Teardown analysis revealed a washer, used for drive shaft installation, was ingested. (figures 6a and 6b)

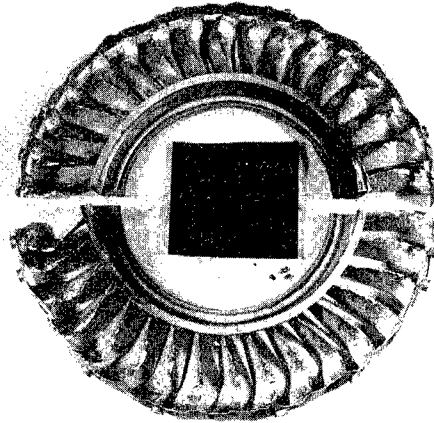
FIGURE 6b.— . . . caused damage to vane assembly.

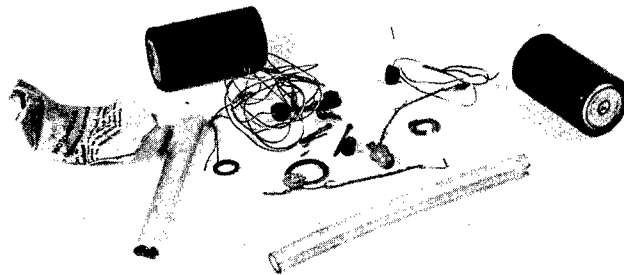
FIGURE 7.—During a safety survey of an airfield, these objects were policed up from the ramp and helipads where aircraft were in operation.

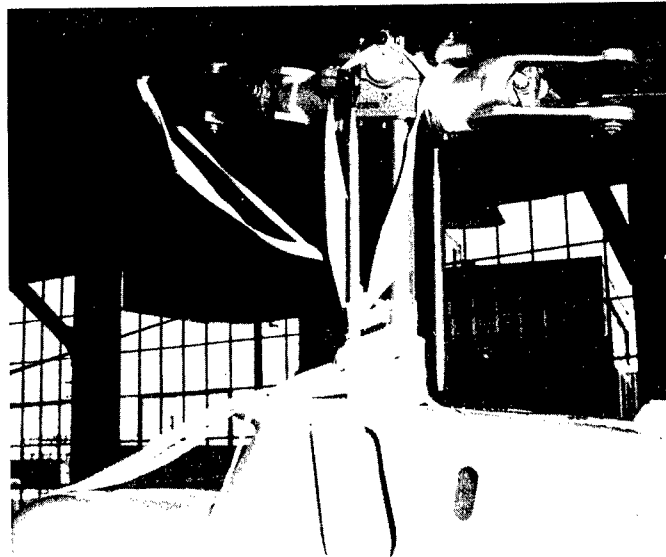
- OH-58A incident, \$182 damage - While OH-58 was at flight idle, another aircraft hovered onto adjacent pad for landing and blew 100-foot section of engineer tape into rotor system. Tape was in mast and around pitch change tubes. (figure 8)

FIGURE 8.—Hovering aircraft blew engineer tape into OH-58 rotor.

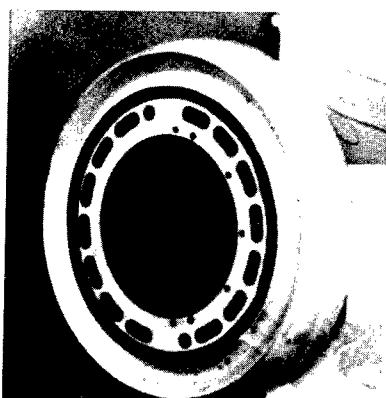
- AH-1G, OH-6A major accidents, \$210,552 damage - During flight unsecured items blew out of ammo bay and passenger areas, hitting tail and causing tail rotor failure. (figures 9a, 9b, and 9c)

FIGURE 9a
Deflector assembly . . .

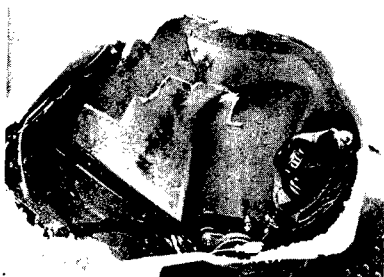
FIGURE 9b
caused tail rotor system to depart aircraft... and caused this.

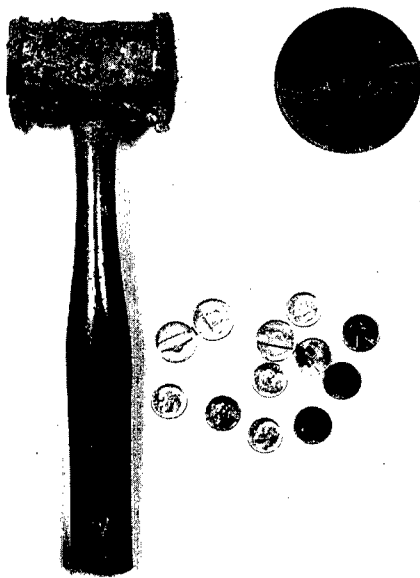
Some time ago, aircraft were brought to a maintenance facility to replace the existing fuel system with the crashworthy fuel system. As part of the routine induction, fuel samples were taken from each aircraft. Laboratory tests revealed particles of unknown substance. Since the fuel system modification was to be accomplished, the contaminated fuel was not a great concern. Defueling and purging of lines were routine. Since no contaminants were found in the lines, further investigation for the contaminant was in order. Inspection of the removed noncrashworthy fuel cells revealed numerous foreign objects. Figure 10 shows what was found in three separate fuel cells. It appears the rawhide mallet was left in the cell at initial installation. The 69 cents in change and the fuel nozzle cap (with the retainer cable) remain a mystery as to how they could have found their way into the cells. The money could have been lost upon installation or repair of the fuel cells and the nozzle cap during a refueling process. Numerous other items such as rivets, fuel nozzle strainer, etc., were also found.

FIGURE 10.—Foreign objects found in fuel cells during modification process.

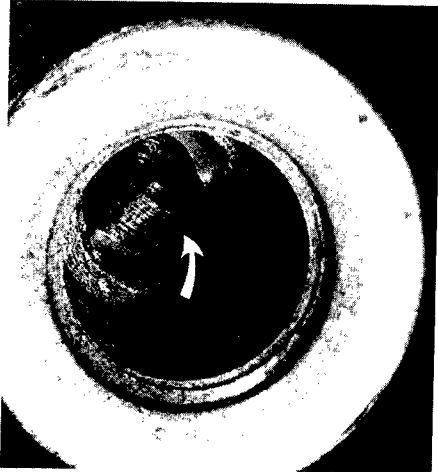
Figure 11 shows a metal shaving which was found in the inlet port of a fuel control, restricting fuel flow.

FIGURE 11.—Metal shaving found in inlet port of fuel control.

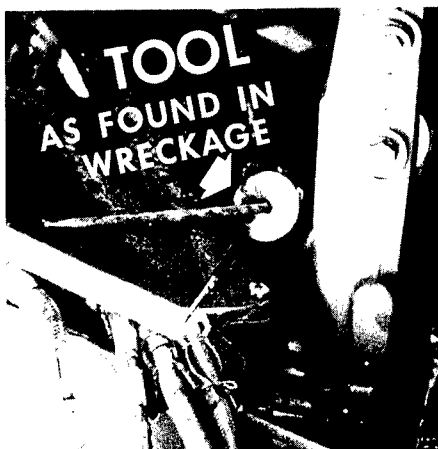
There were cases where tools were found at accident sites but they were not considered causes or contributing causes of the accident. One such case was an AH-1G major accident. A pair of side-cutting pliers was found in the fuselage. The pliers were very rusty and unusable, and did not display any fresh markings. Other tools found in the wreckage included a screwdriver (figure 12) and a 7/16 open-end wrench (figure 13)

FIGURE 12.—Screwdriver found in wreckage of AH-1G.

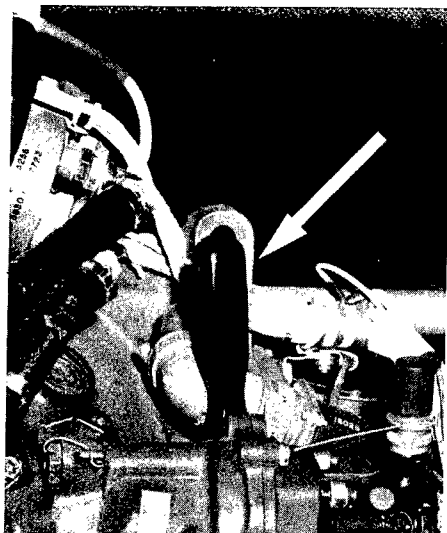
FIGURE 14.—Eighteen-inch screwdriver found on UH-1 engine.

Figure 14 depicts an 18-inch screwdriver found on a UH-1 engine. At least five different pilots had flown this aircraft and it had gone through two intermediate inspections before the screwdriver was found during the third inspection.

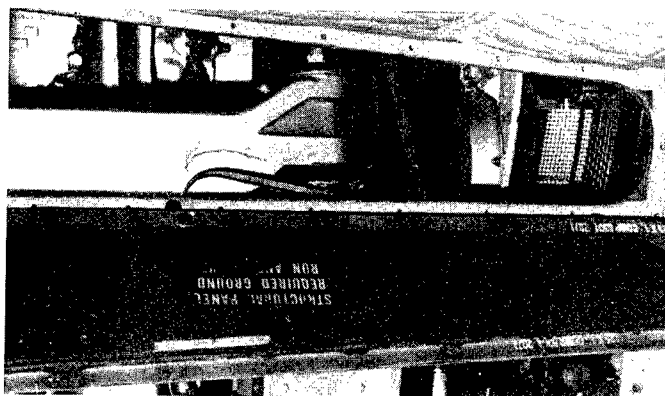
Figures 15 and 16 show damage to a UH-1H main transmission support case. A crew chief noticed something wedged between the transmission and side structural panel. Removal of the panel revealed the damage. It is suspected the cotter key removal extractor was dropped in the transmission well while work was being performed in the area of the main rotor hub assembly 25 to 30 hours before discovery. Damage resulted in replacement of the main transmission.

FIGURE 15.—Cotter key extractor found in transmission support case.

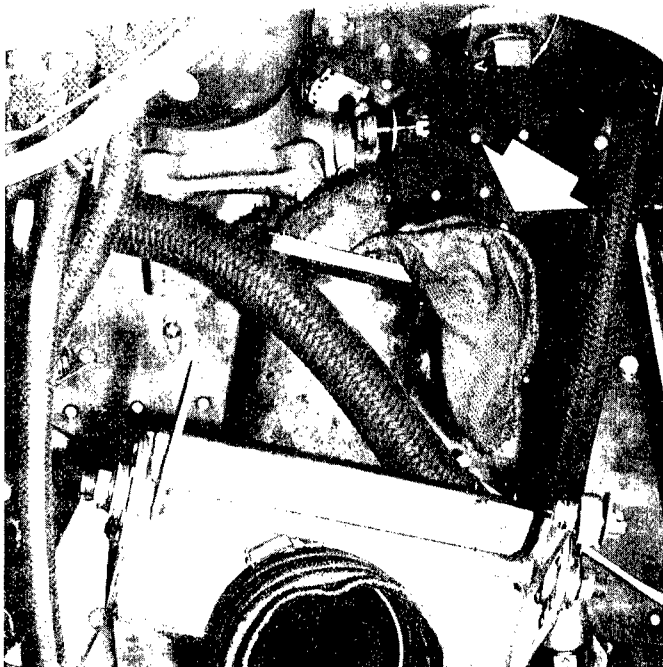
FIGURE 17.—Rag lodged in carburetor induction elbow assembly.

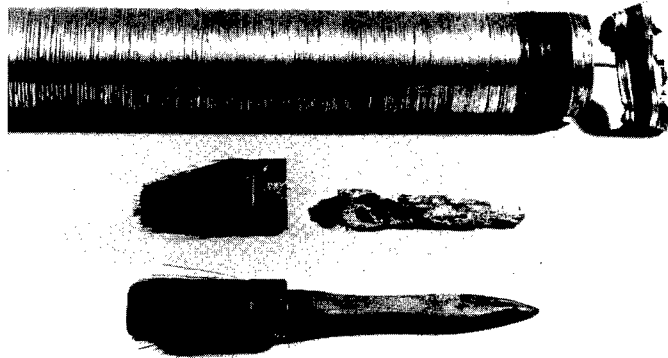
- UH-1H minor accident, \$4,366 damage - Landing approach was made and terminated at hover. During hover, sound was heard and directional control was lost. After one complete clockwise rotation, aircraft touched down. The third section of the tail rotor drive shaft had failed due to FOD caused by paint brush. (figure 20)

FIGURE 20.—Sheared tail rotor drive shaft caused by paint brush. New brush is shown with brush that caused damage.

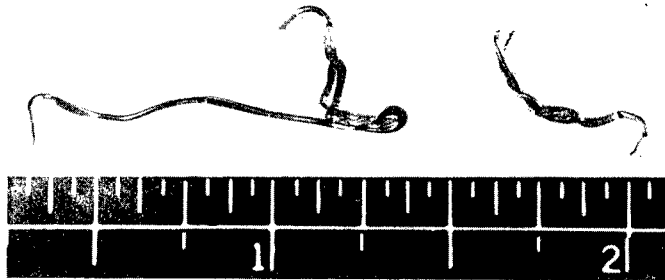
Figure 23 shows safety wire residue found in the gearbox assembly of a T63A700 engine. The engine was undergoing analysis for a different reason, but the fact remains that the wire could have caused an emergency.

FIGURE 23.—Safety wire found in engine gearbox assembly.

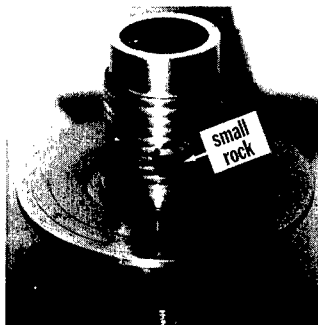
FIGURE 25.—Rock in fuel sump drain valve allowed it to be stuck in open position.

wheels and a tug, a skid could have dragged on the concrete, creating a spark and igniting the 262 gallons of JP4 pouring on the ramp. What caused all this? A small rock was found lodged in the spring mechanism of the push drain valve.

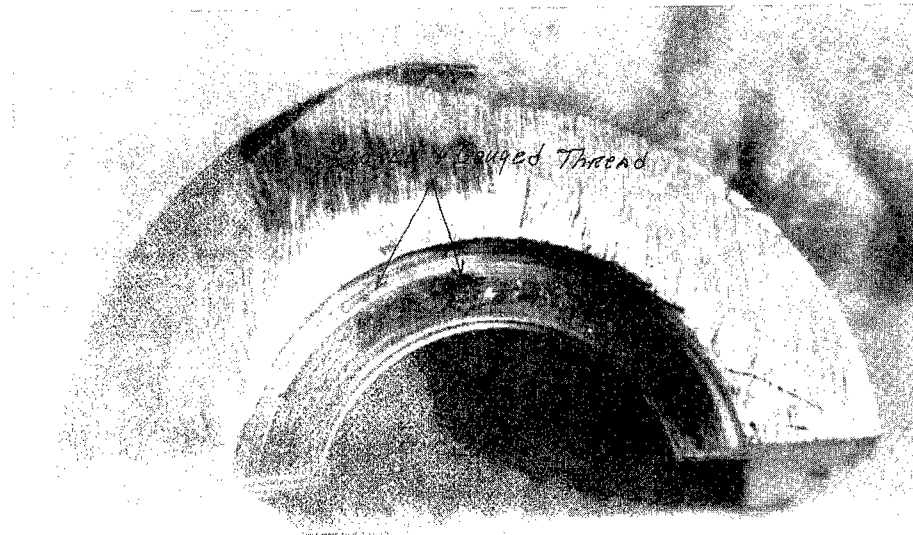
Particles of sand and other foreign matter can cause extra work due to inspections and time required for retaking oil samples. Figure 26 shows an enlarged internal thread area of a UH-1 tail rotor control quill. The threads were scored and gouged from the sand and other foreign particles during movement of the control quill. Particles of the soiled film lubricant and the base metal can work into the tail rotor gearbox. These minute particles, together with excess grease from the crosshead assembly, can damage the 90-degree gearbox.

FIGURE 26.—Scored threads of UH-1 tail rotor control quill. Damage caused by sand and other foreign particles.

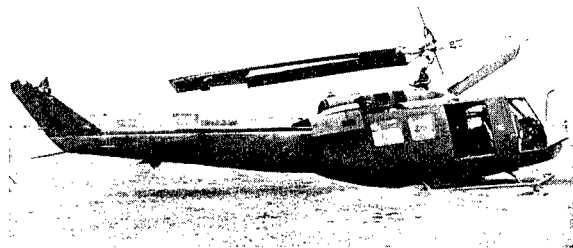
- UH-1H major accident, \$73,000 damage - Aircraft was in level flight when loud bang was heard and tail rotor loss occurred. Aircraft hit hard and blades struck ground. Engine inlet cover had been left on roof of aircraft during preflight. Cover struck red tail rotor blade, and tail rotor, 90-degree gearbox, and a portion of the drive shafting separated from aircraft. (figures 27a, 27b, and 27c)

FIGURE 27c.—
. . . and caused this.

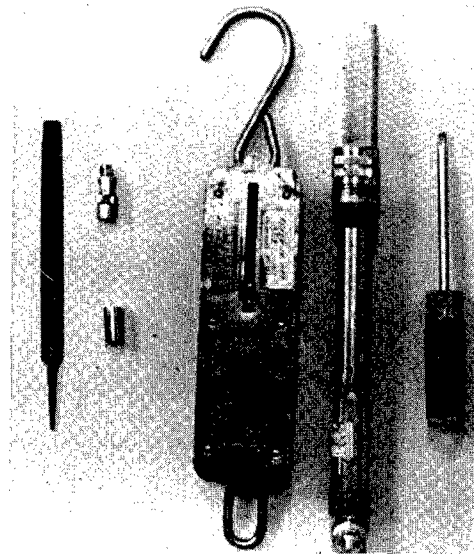
FIGURE 29.—This 1/4-inch wrench was found during a proper daily inspection. Aircraft had been out of PE 3 weeks and had 5 hours' flight time.
